AIRCRAFT ACCIDENT  
IDENTIFICATION  
NO.

704 05 101

a. The Accident. A-3B, BUNO 138917, assigned to HEAVY ATTACK SQUADRON ONE TWO THREE (VAH-123) and piloted by LCDR Richard Earl PARKS, USN, (b) (6) crashed (ALFA) on a snow covered mountain at the 7000-foot level, at 1432(U), 5 April 1967, eight miles southeast of Alturas, California. The four occupants of the aircraft sustained fatal injuries in the crash. The crash site was in a U. S. Forest Preserve, and property damage was limited to broken trees.

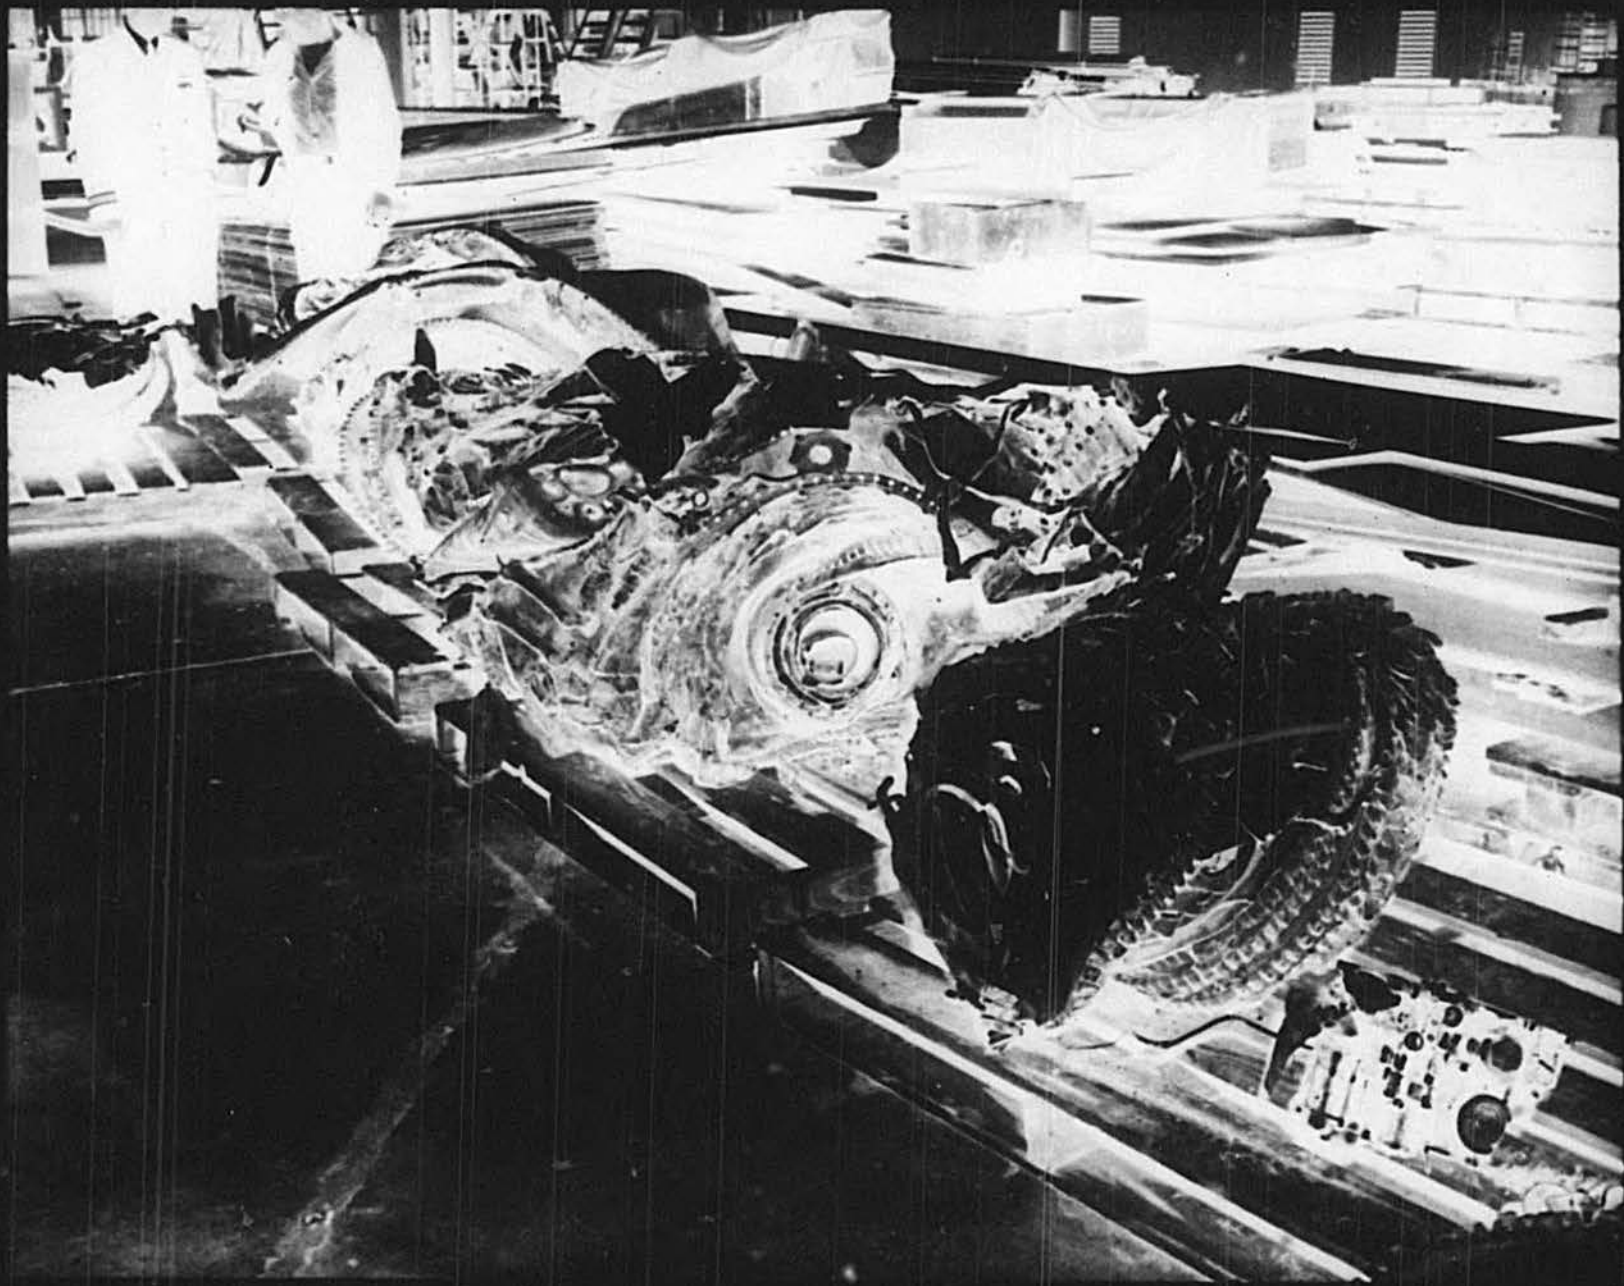
a. Visual inspection revealed that both engines had suffered major impact-type damage. Engine rotating components were found severed into five sections, as shown in enclosure (1).

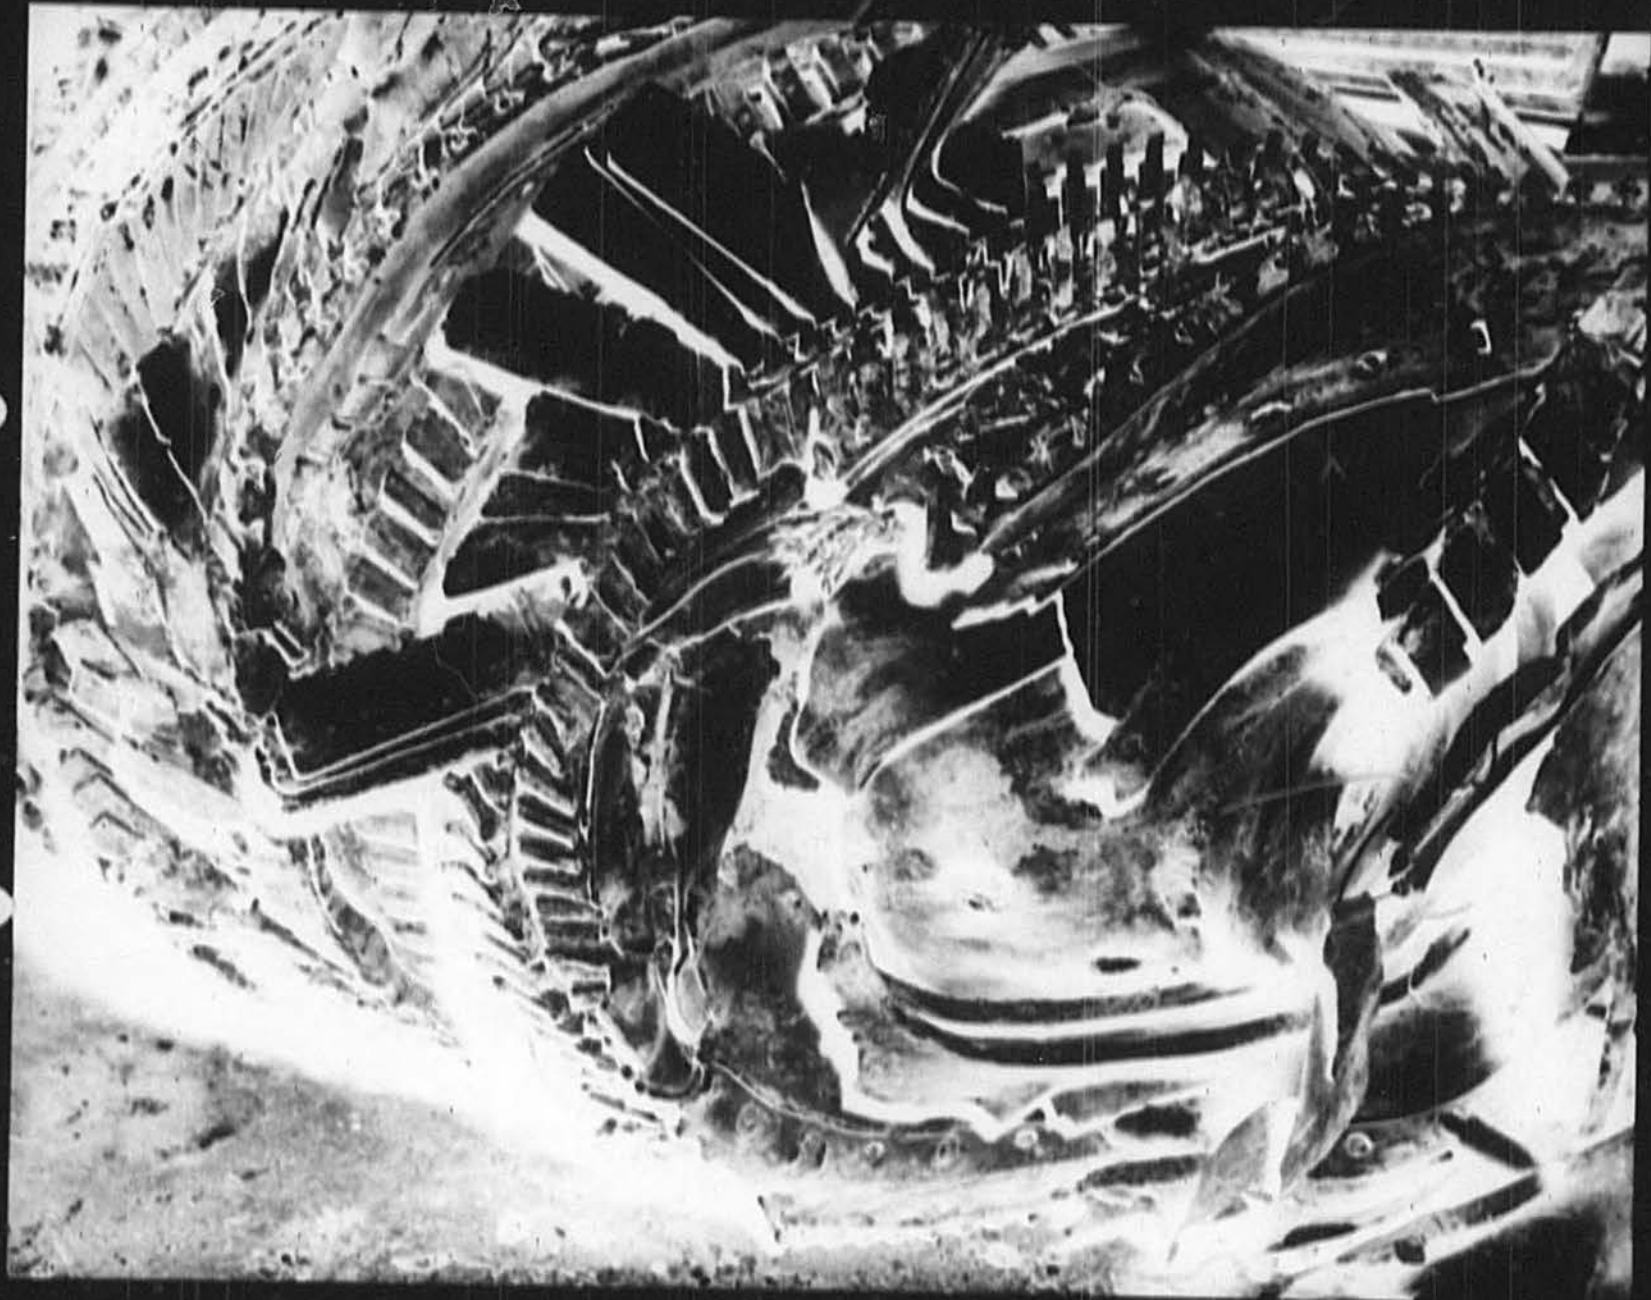
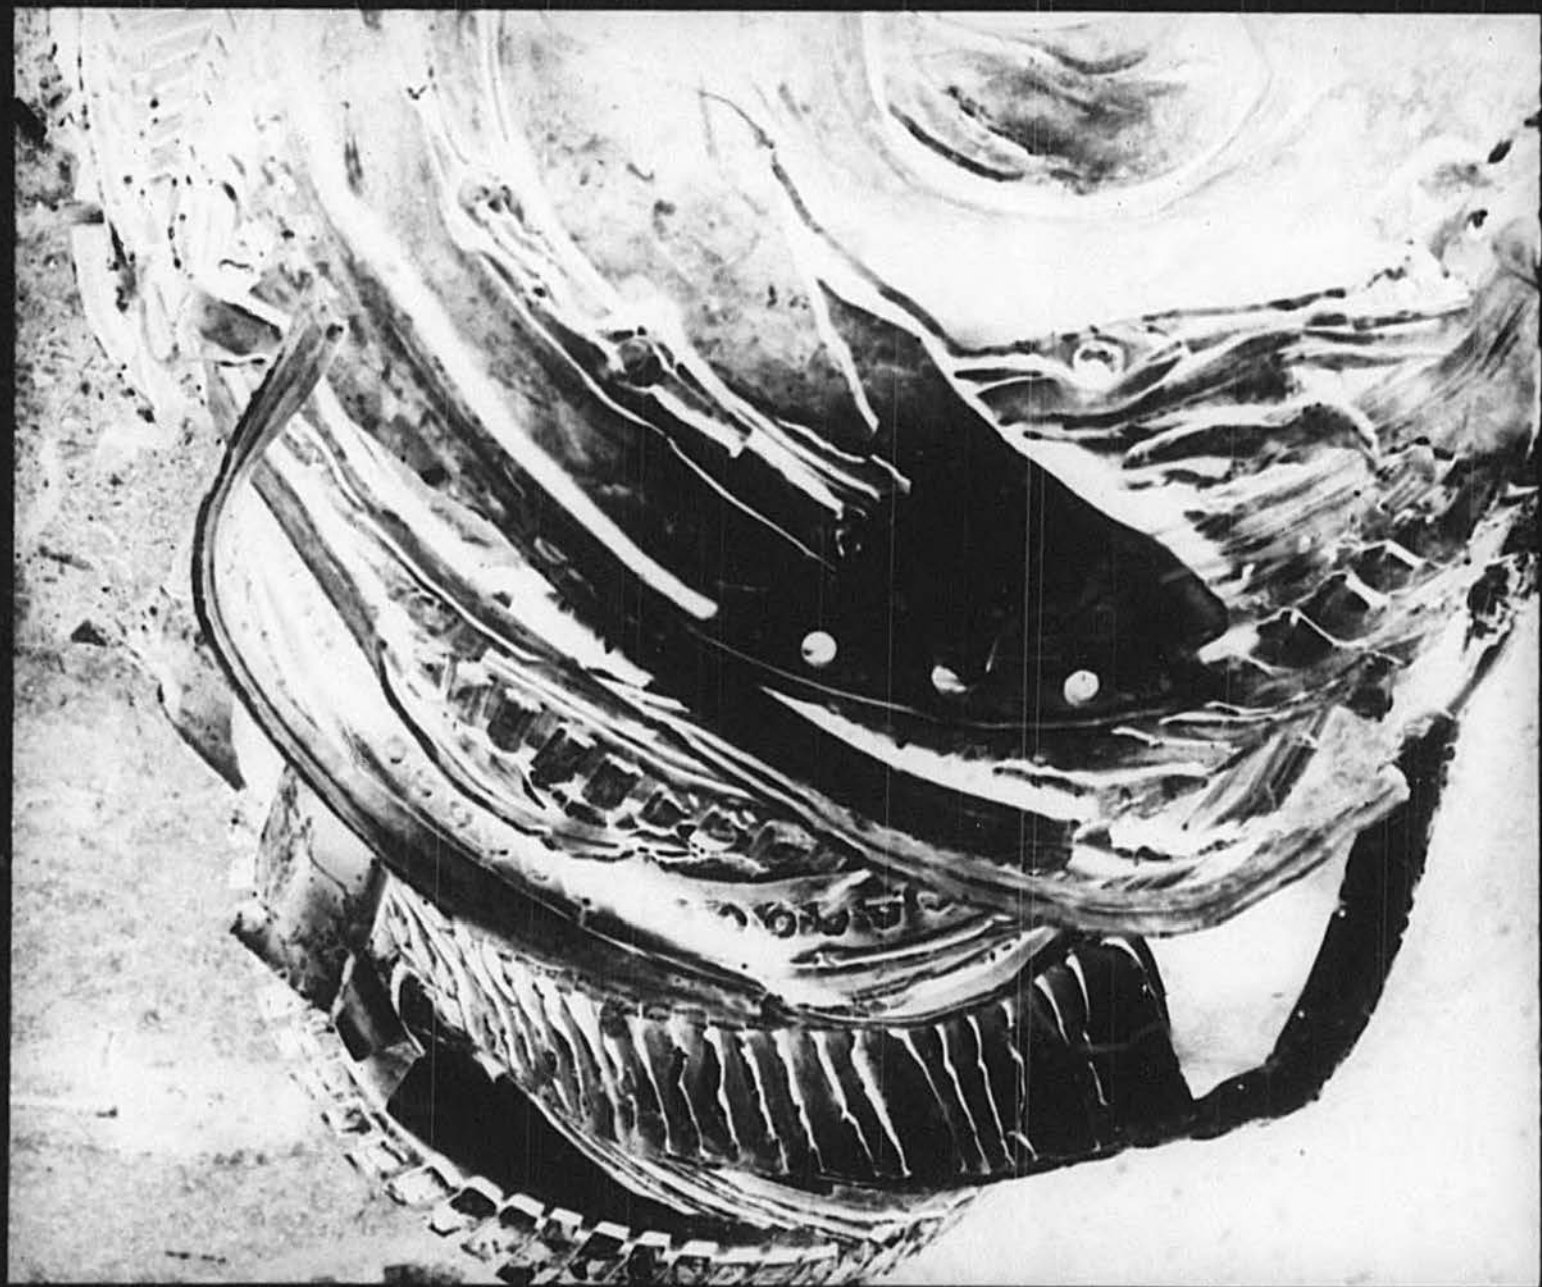
b. Examination of damaged parts from L/H engine S/N P607625, i.e., N<sub>1</sub> and N<sub>2</sub> compressors, as shown in enclosures (2) and (3), respectively, revealed that the compressor blades were relatively straight and negligible rotor rotation was in evidence, indicating that engine speed was low RPM or rotors stopped at impact.

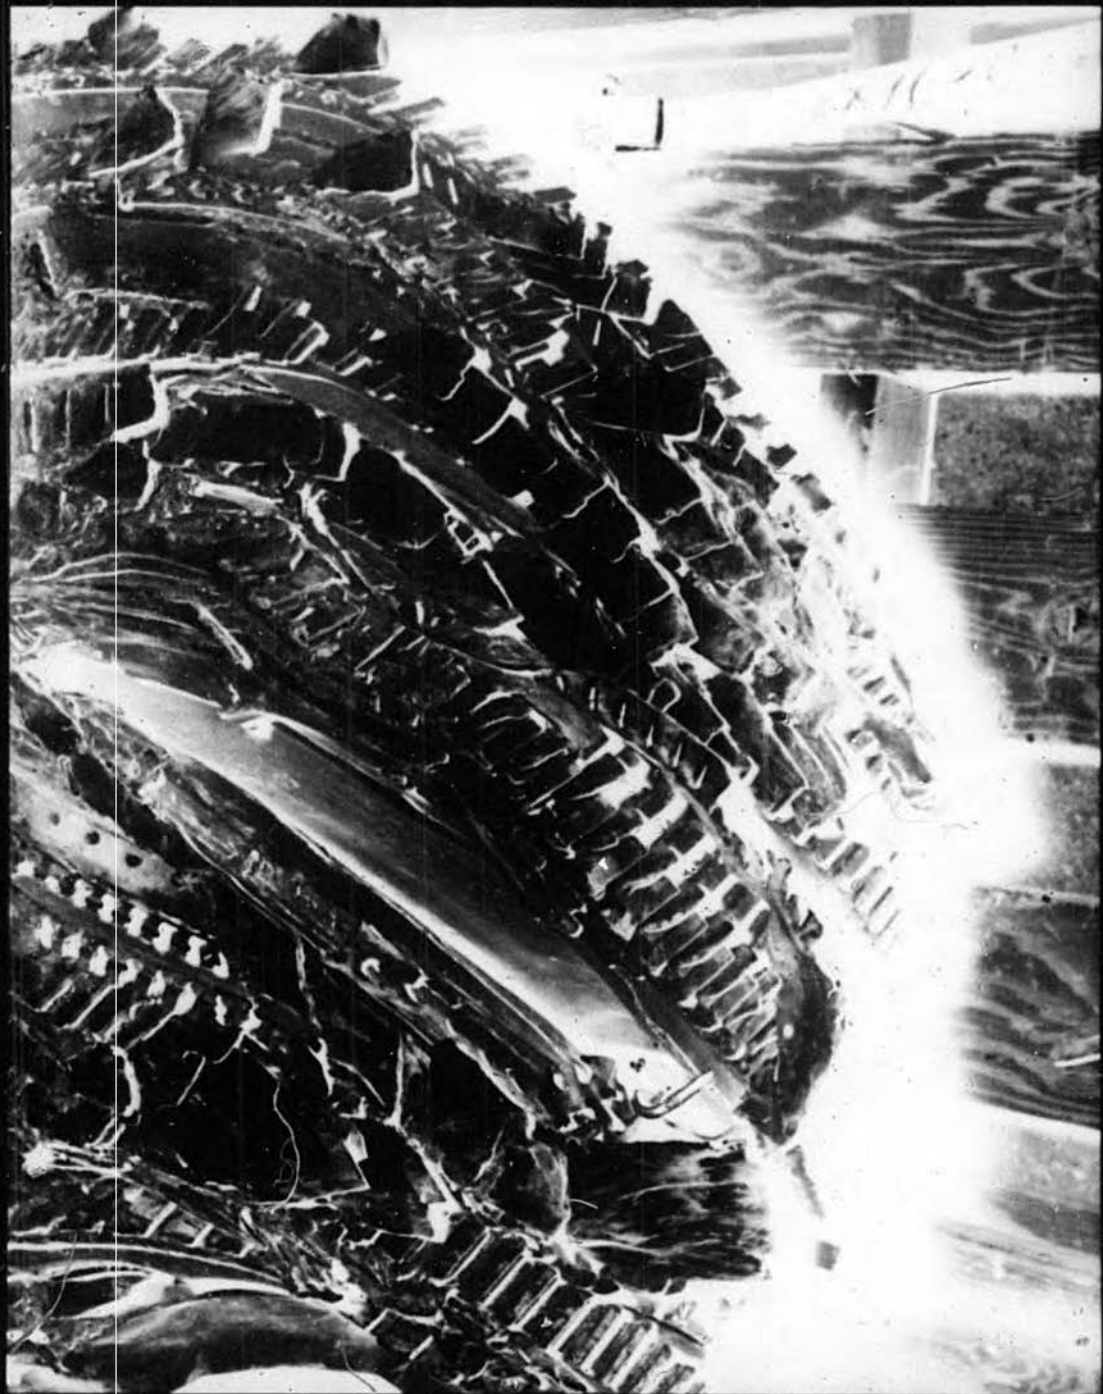
c. Examination of damaged compressor parts of R/H engine S/N P632289, indicated rotor rotation at impact. Engine speed was probably in the idle RPM range, as disclosed by the anti-rotation right-angle bending and clipped-off N<sub>1</sub> and N<sub>2</sub> compressor blades shown in enclosure (5).

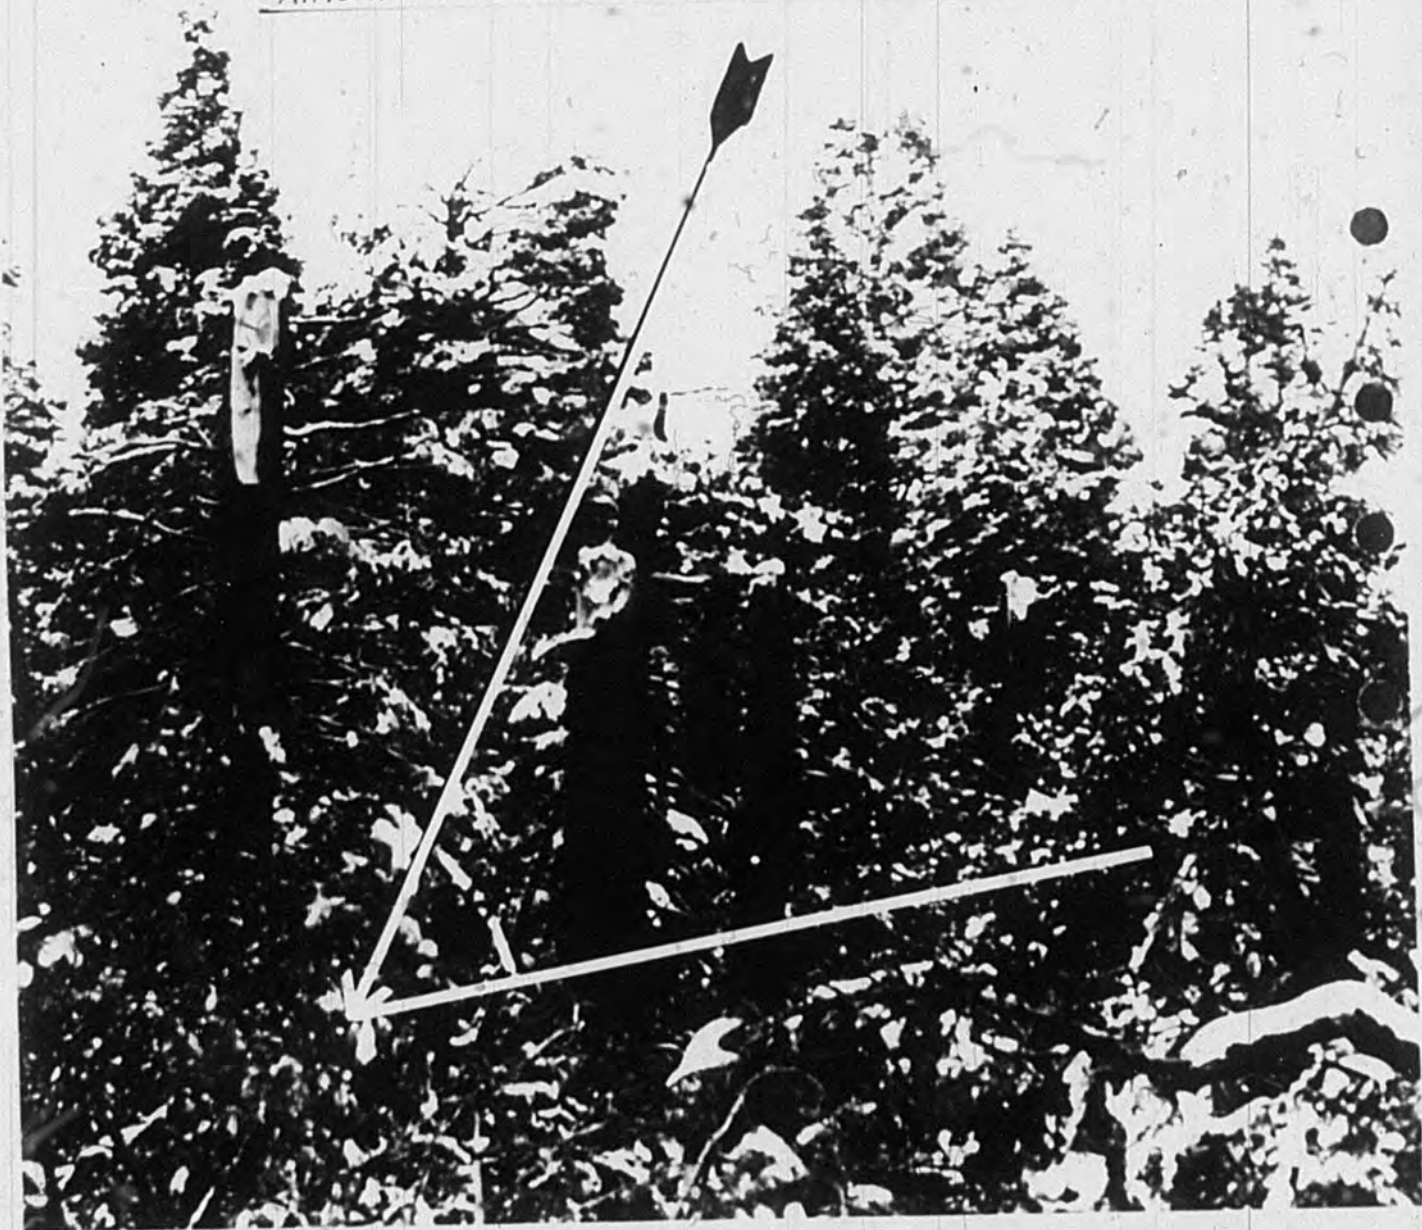
9. IMPACT ANGLE

Examination of the site and severed trees along the flight path indicates that the aircraft initially encountered the top of a tree in a nose low, slight right wing down condition heading 205° magnetic. Continued tree contact for approximately 400 feet at a 35° dive angle caused the aircraft to impact the ground in a slight left wing down condition. Explosion occurred upon contact with the trees. The identification and positioning of the wreckage confirmed that the aircraft had been in an upright attitude with some degree of left wing down condition at impact. At or near the impact point no indications of ground fire existed. However, upslope 300' to 900' slightly burned patchy areas were evident indicating residual ground fire of short duration.

AIRCRAFT ENTRY ANGLE INTO IMPACT AREA

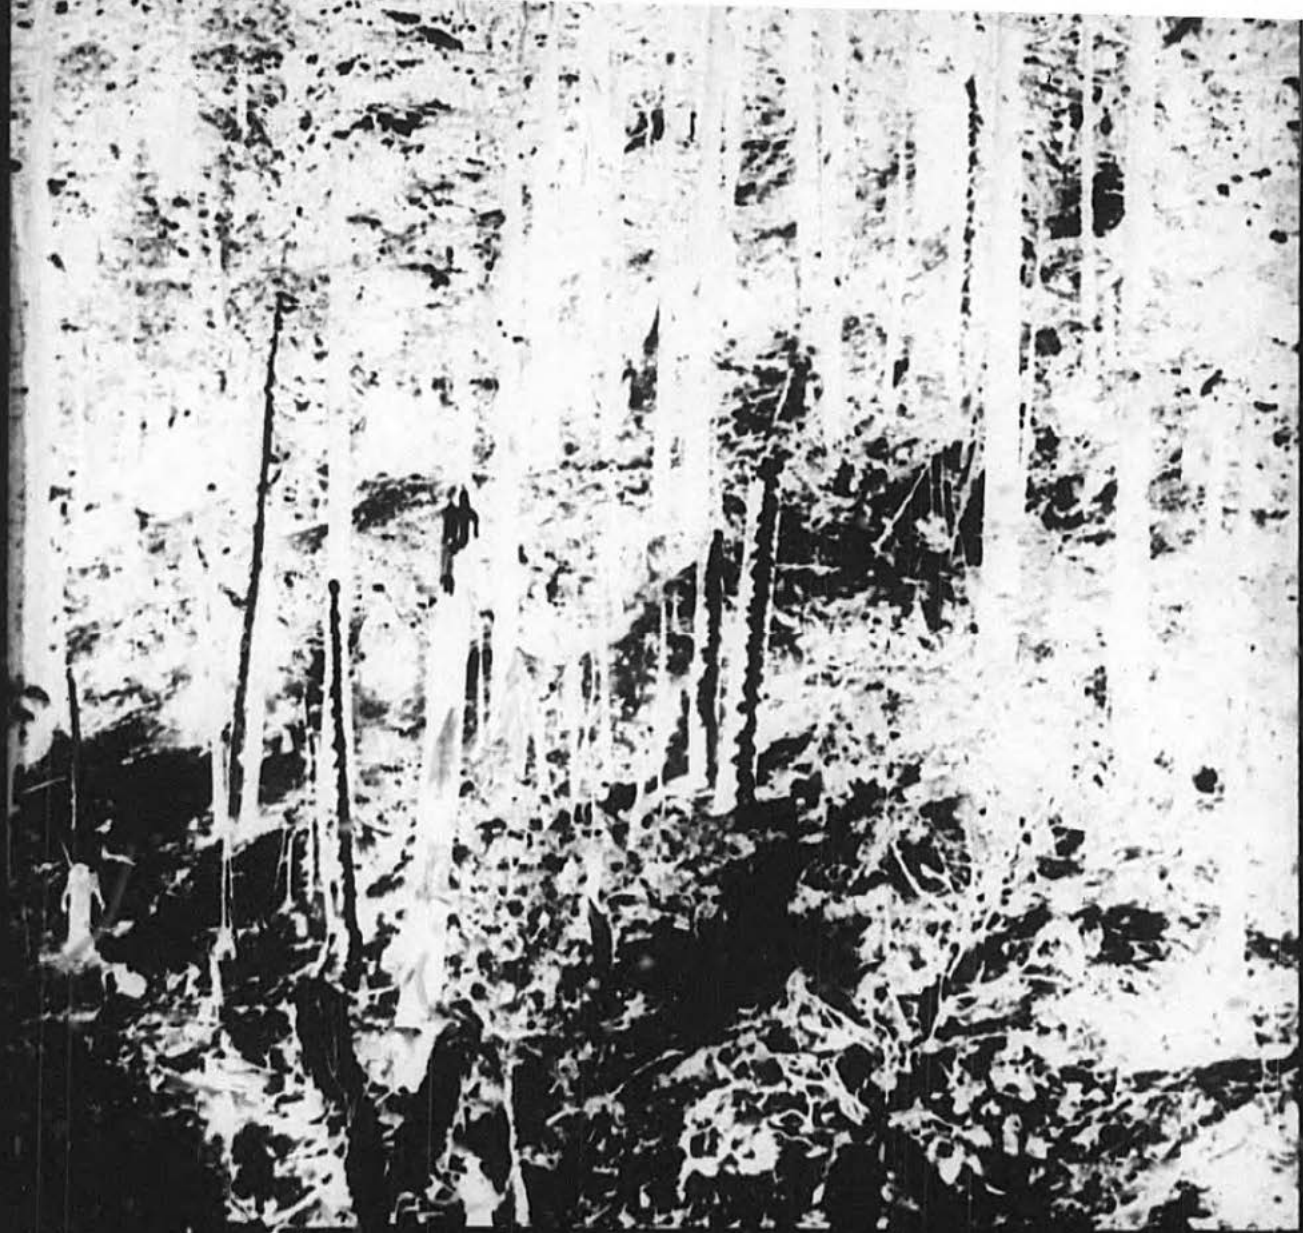
9-4 WRECKAGE SITE

The aircraft sustained ALFA damage as a result of impacting a thickly forested area in a 35° nose down, upright attitude. Explosion occurred following impact with several massive trees and wreckage was strewn over an area approximately 2000' X 500' against a rising 40° slope in a conical expanding pattern. Complete examination of the wreckage was not possible due to heavy snow cover and fallen trees in the initial impact area. Prior to impact the aircraft had severed numerous trees as it approached the ground. The area upslope showed patchy areas of residual ground fire of short duration. Fragments of nose radome and port outer wing panel were located along the flight path 350 feet prior to the impact area. Fragmentation of the aircraft was severe and no components were found intact. Engines were located up slope from the impact center, the port engine broken into 2 major sections and the starboard into 3 sections. All recovered engine sections and accessory components that could give evidence of inflight operation were salvaged and shipped for DIRM.

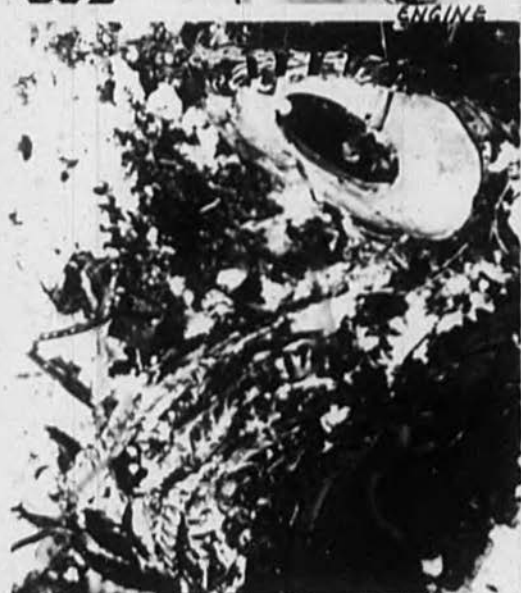
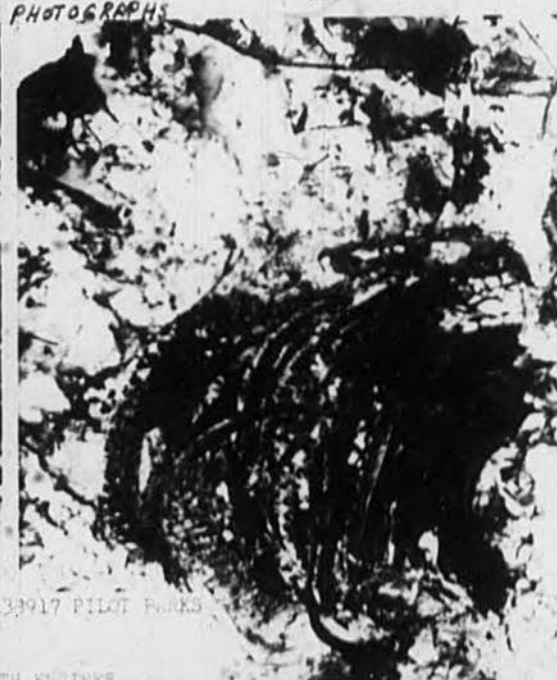
ENGINE PHOTOGRAPHS

Major sections of both engines were located. The port engine sections were to the left of the crash path. All sections were severely damaged with some discs and the majority of compressor and turbine blades missing. Very little engine case remained attached to the main bodies. Shafts showed little evidence of torsional failure. A number of Z bent compressor & turbine blades were found, some remaining on the engine, others located from digging efforts. No large compressor blades from the port N-1 compressor were located. Major pieces of fuel control, fuel heater and oil filter were found near the left side of the impact point. All port engine components and accessories that could be found were shipped to NAS North Island for DIR. Enclosure (10) contains photographs of engine sections.

The starboard engine was found in three sections. The compressor and burner sections were partially surrounded by engine casing while the turbine section was devoid of external cover. Again, the majority of blades were missing from the engine, however, numerous blades were recovered along the starboard side of the flight path. Shafts showed some evidence of torsional failure. No engine accessories to the starboard engine were found. All components located were sent to NAS North Island for DIR. Starboard front engine sections, speedrings or oil coolers were not located.

ENCLOSURE (10) VIEWS SHOWING DAMAGE TO BOTH ENGINES  
SPECIAL HANDLING REQUIRED 14W OPNAVINST 3750.6E

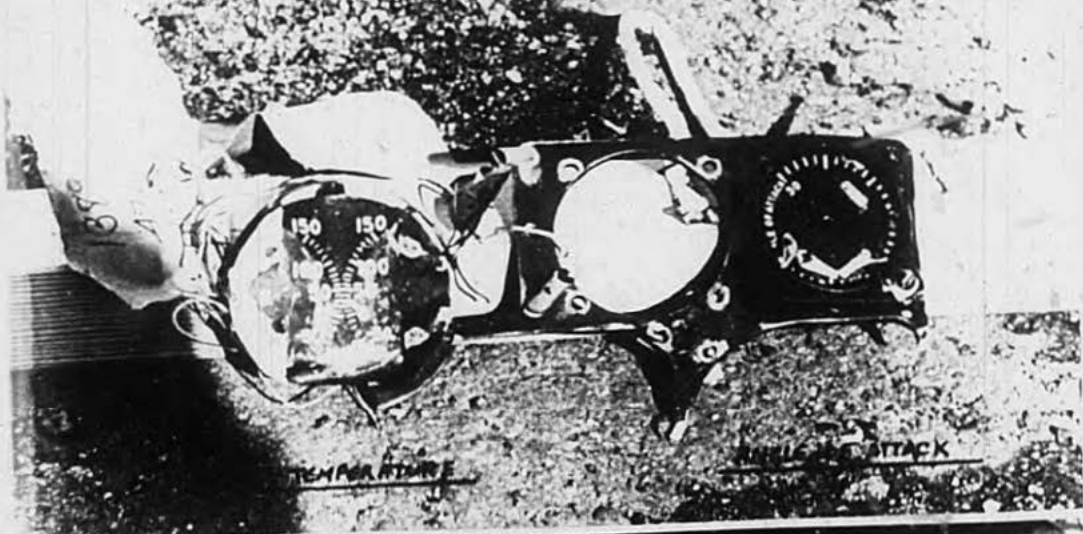
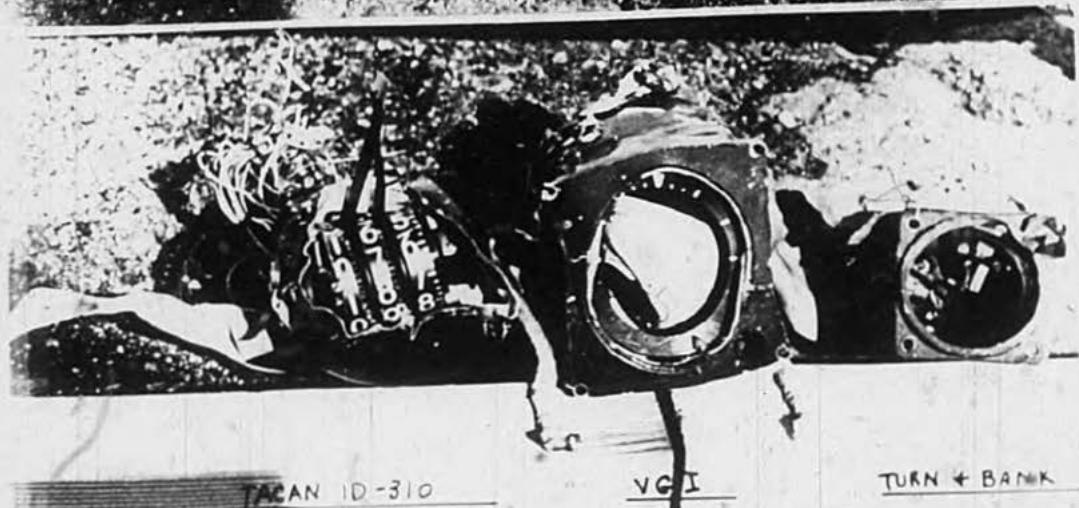
11 COCKPIT INSTRUMENTS

A number of cockpit instruments were recovered. The T/CAN DME gauge, VGI, standby gyro, angle of attack and turn & bank were found and submitted for DIRM. A portion of fiber glass curtain approximately 1½' X 2½' was recovered and found charred though its location was in an upslope area devoid of other ground fire indications. One of the two escape chute actuating cylinders, found nearly intact, was submitted for DIRM.

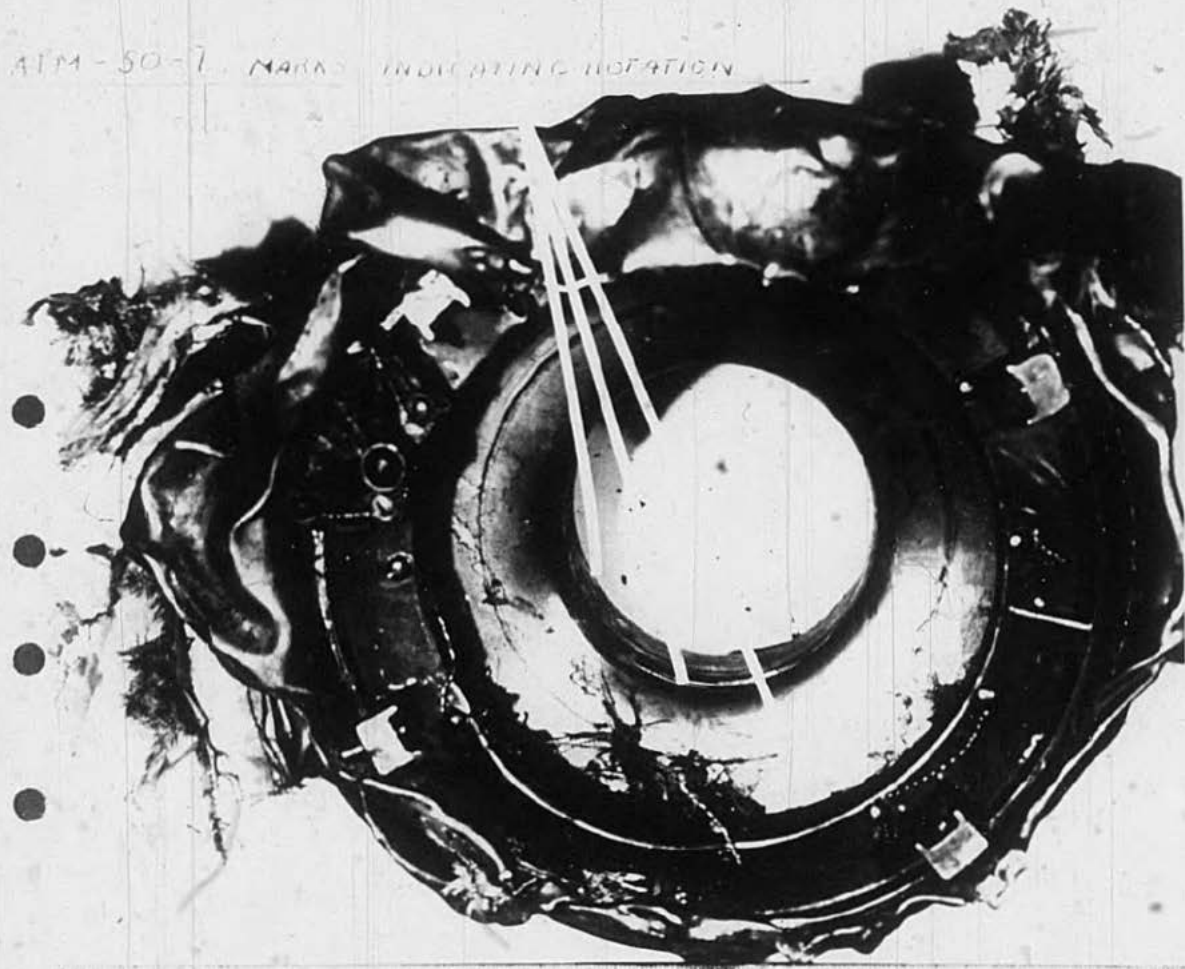
ATM-50-7 MARKS INDICATING ROTATION

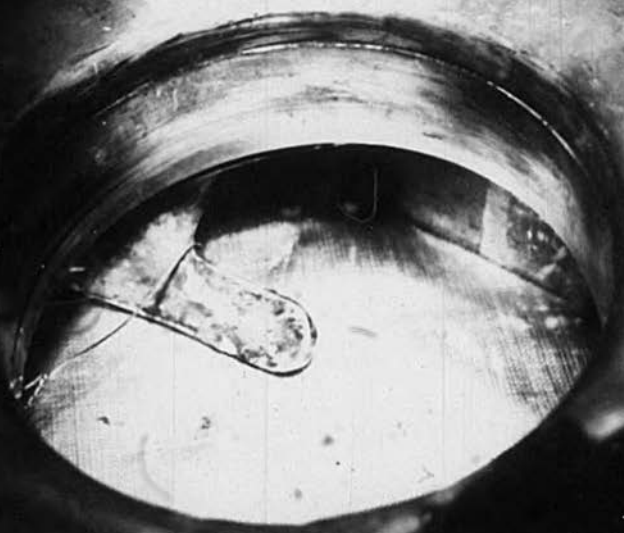
11-2 #2 ATM SCROLL

ROTATION
